APPENDIX D

St. Clair County Health Department Tributary Monitoring Program

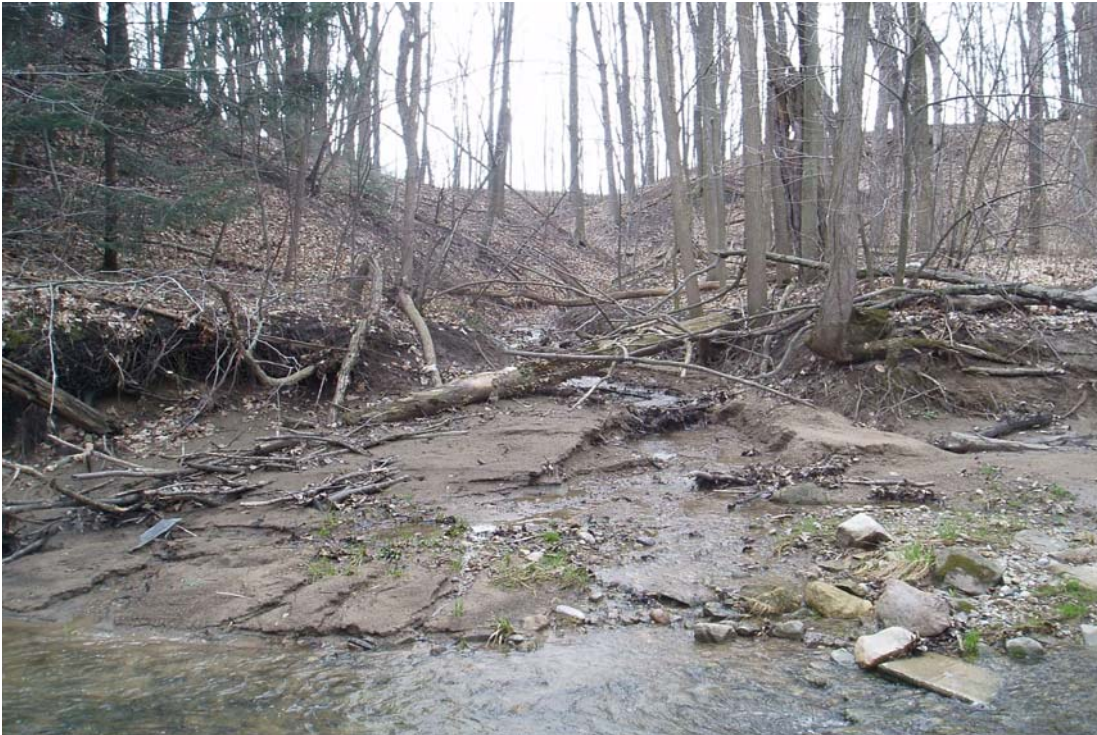
Burtch Creek is located within agricultural and rural land use areas. Most of the smaller tributaries have been channelized in the past and approximately one third of these tributaries appear to be poorly managed (Fig. D-2.1). Common practices with negative impacts include farming within and directly adjacent to tributaries, cattle access, mowing or burning riparian vegetation, channelization, perched culverts, and conversion of riparian vegetation to turf grass. At the monitoring site near State Street, sediment appears to have deposited within the floodplain to the extent that the channel is now relatively straight and incised due to historic land use practices (Fig. D-2.2). The floodplain refers to a geomorphic feature of the channel as opposed to the 100-yr floodplain (further described in Section D-5.1). As a result, the banks are severely eroding and the sediment discharge is very high during moderate and high storm events as noted by the steeper curve and higher Y-intercept in Figure D-2.2.

Figure D-2.1 Alluvial fan created by excess sediment supply from agricultural tributary

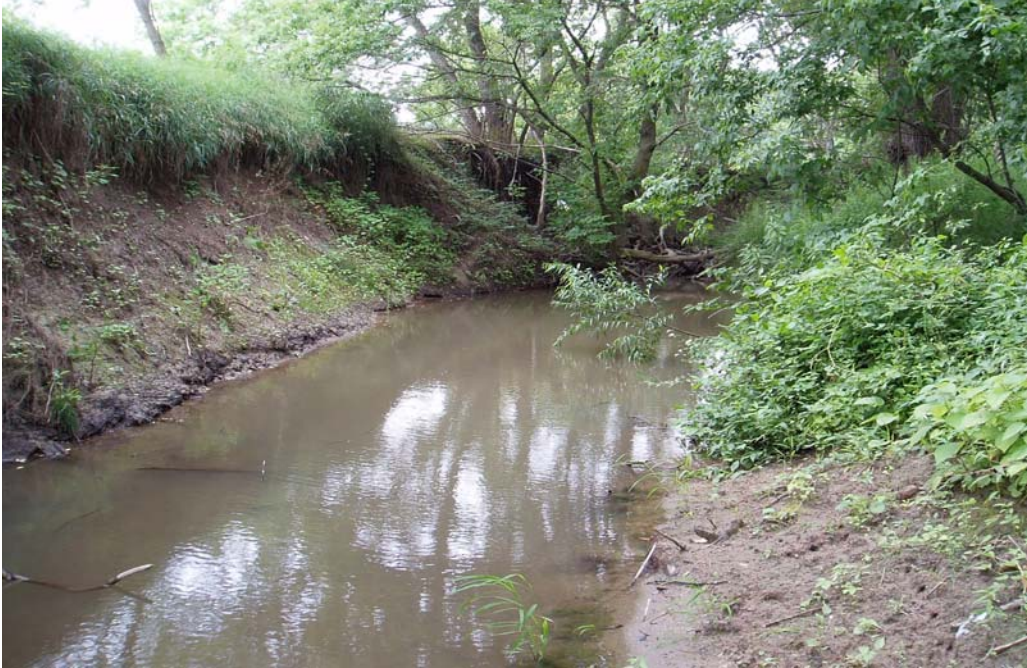
General Stream Channel Condition – Conditions of the main channel of Burtch Creek are unstable with very high sediment loadings from both in-stream and upland sources. The spring season flows on Burtch Creek generally appeared to be more flashy than Carrigan Drain during storm events. Based on a windshield survey, approximately one third of the first order tributaries to Burtch Creek are unstable and poorly managed. A concrete culvert has been recently installed under State Street. The previous culvert was perched and may have been under-sized. Channel bed erosion downstream of the culvert is continuing to progress downstream.

Bed Features – A longitudinal profile of the creek was not measured. In a few locations, the bed was eroded down to a hardpan parent material. In most areas, significant sediment bars of sand and fine gravel were present because the creek does not have the capacity to transport its high sediment load. There were no riffles evident and the only pools were below the road culvert.

Figure D-2.3 Burtch Creek Downstream of the State Street Monitoring Site

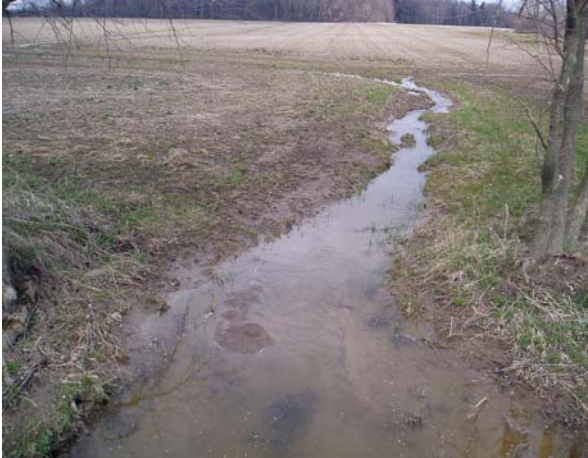
Figure D-2.4a Poor Riparian Management

Headwater tributaries that are contributing excessive sediment loads should be stabilized as a first priority (Fig. D-2.4a). Where agricultural drainage is required, a two-stage ditch design should be used by excavating a floodplain bench on one or both sides of the channel. The final capacity of the channel should allow for mature grasses, sedges, and some shrubs (Fig. D-2.4b). The main channel of Burtch Creek downstream of State Street is deeply incised and cannot be restored without active intervention (Table D-2.3 under Recovery Potential).

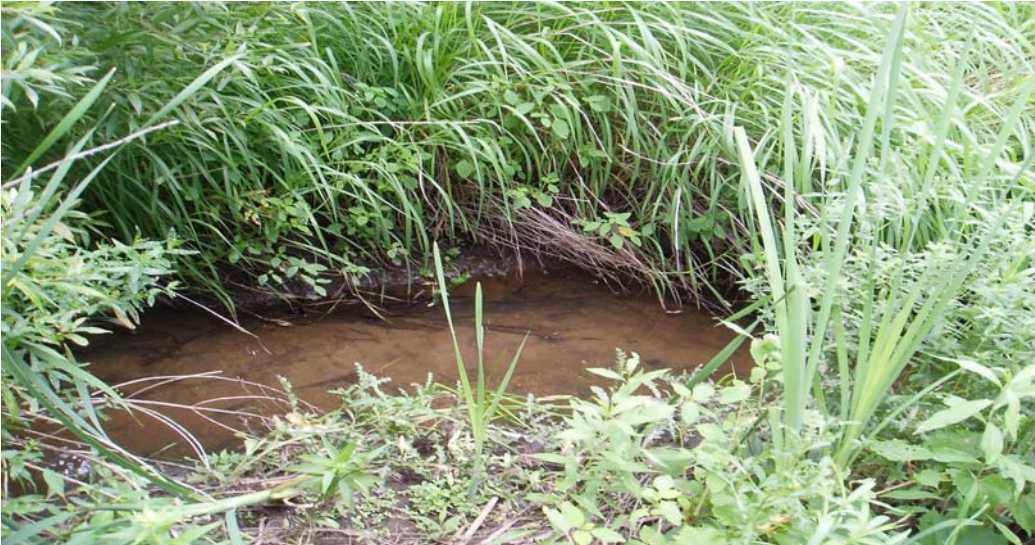
Carrigan Drain is an established County Drain located within predominantly suburban land use areas. It appears that when the drain was last maintained, it was constructed with a high width/depth ratio and a large capacity to contain flood-sized storm events. As constructed, the overly-widened drain did not have sufficient energy to transport its sediment load. Subsequently, deposition occurred along the margins of the channel to form vegetated floodplain benches along either side of the channel. This narrowed the active channel and created the stable channel that is evident through much of the drain. Exceptions occurred at overly-wide and shallow reaches near culverts or with excessive tree canopy.

Figure D-3.1 Stable Reach of Carrigan Drain Upstream of the Monitoring Site

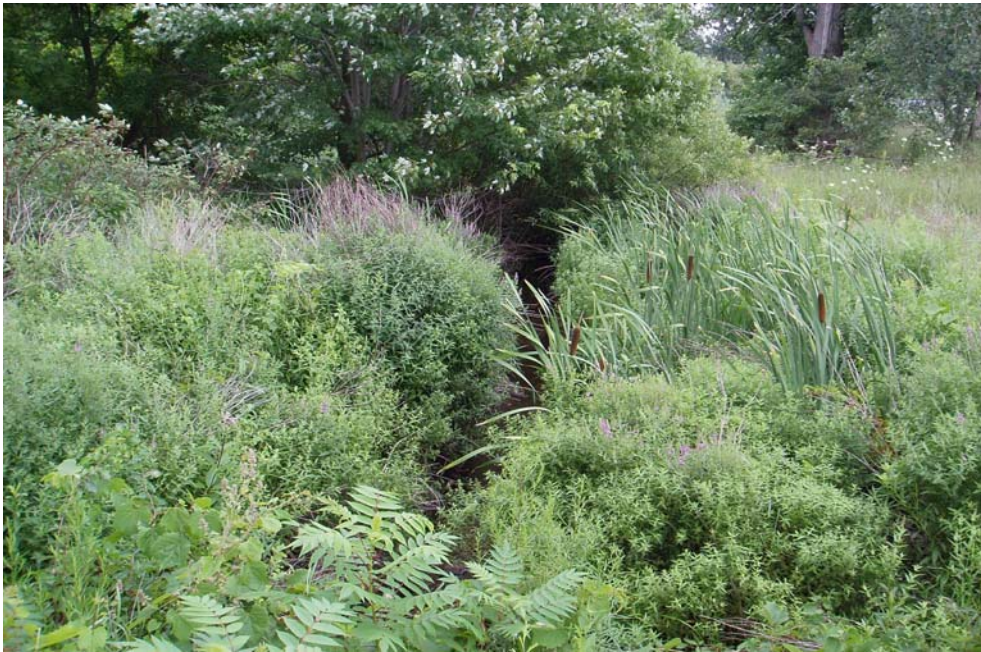
General Stream Channel Condition – Physical conditions of the main channel of Carrigan Drain are generally the most stable of the three streams monitored. Even though this tributary received runoff from commercial and highway areas, the discharge in the drain was consistently low (much less flashy) during rain events. It was difficult to establish stage-discharge relationships for moderate flows because the gauge height did not rise very often. The channel stability and flow attenuation may have been due to the larger width of the floodprone area (Fig. D-5.1).

Figure D-3.2 Carrigan Drain Upstream of Lakeshore Road Monitoring Station

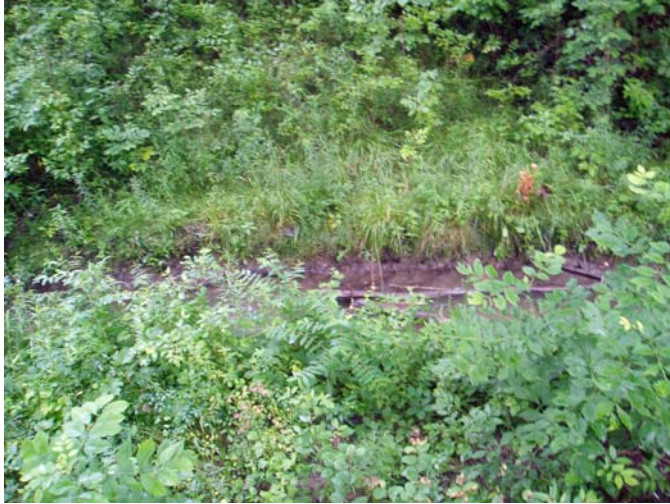
Cuttle Drain is an established County Drain located within predominantly suburban land use areas. Similar to Carrigan Drain, when the drain was constructed, it was built with a large capacity to contain flood-sized storm events. However, the drain was not built to the same width as Carrigan Drain (although they had a comparable drainage area). As a result, it maintains a predominantly trapezoidal shape (Fig. D-4.2b). Exceptions occur where intermittent side bars have begun to form a floodplain bench (Fig. D-4.1). Much of the banks of the drains are mowed or regularly cleared of brush.

Figure D-4.1 Cuttle Drain with Intermittent Side Bars

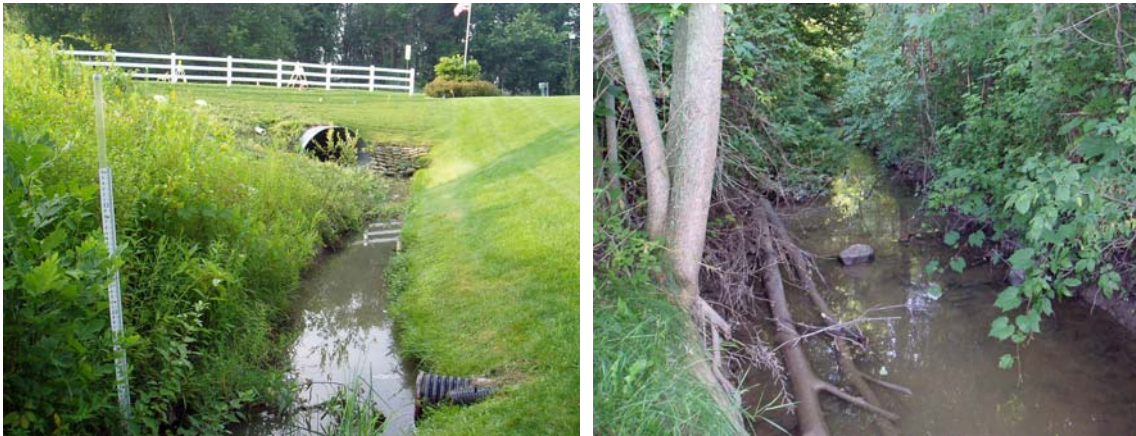
General Stream Channel Condition – Conditions of Cuttle Drain are moderately unstable with sediment discharge values typically between Burtch Creek and Carrigan Drain (Fig. D-1). The drain is highly entrenched and much of it is maintained. During recent construction, the floodplain was further filled on both sides of the tributary east of Covington Lane and soil erosion control measures were not adequate. The entire watershed was not evaluated, but upstream tributaries tended to be more entrenched than the monitoring site.

Figure D-4.2a&b Carrigan Drain at Monitoring Site: Facing Downstream (left) and Facing Upstream (right) Respectively

Lateral Stability – The channel is highly confined within a moderately unstable trapezoidal channel. Toe scour is evident, but there are no signs of mass wasting (severe bank erosion). The Meander Width Ratio is approximately 3 which is moderately confined for a C channel and severely confined for an E channel.
